**Flood Control Project Maintenance
Levee Inspections**

Fall 2018 Levee Maintenance Deficiency Summary Report

Sacramento River Basin

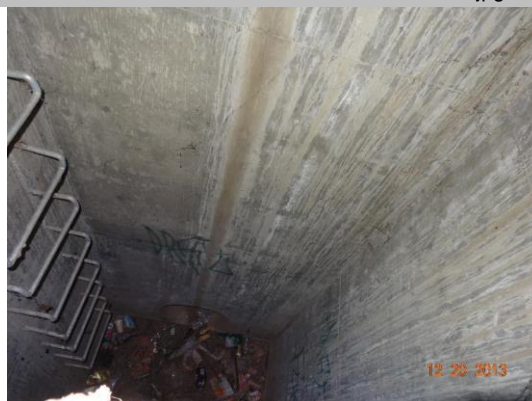
Photo 3 of 3 : UCIP_FA_2018_29326_54320.jpg

Comment Code						
Inspector Comment						
FS_ID:29326 DS_ID:24375 EP_NO: N/A Repair Type: No Action Needed Crossing Status: Found UCIP Comments: 08/16/2017 DWR Deferred Maintenance Project (DMP), Vince Rodriguez, forwarded email received from Tim Kerr, General Manager of American River Flood Control District (ARFCD) with file "DWR Eligible Pipes Found in ARFCD" from ARFCD that shows the ownership and location of the pipes Tim Kerr investigated. Owner of this crossing is identified as the City of Sacramento, ARFCD Staff Notes indicate Arcade Ck. (DWR UCIP - O. Magana) 06/14/2017 This crossing is scheduled to be cut and replaced as part of Sacramento Area Flood Control (SAFCA) North Area Streams (NAS) Levee Improvement Project: City of Sacramento Utility Permit Modifications Along Arcade Creek Levees. Unable to confirm when pipe will be replaced. Need to coordinate with owner and DWR FPIIB Inspector to determine when project is expected to start. (DWR UCIP - O. Magana). FIELD_STRUCT_DESC: 24-inch corrugated metal (CM) drainage pipe through the levee, 8.6 feet below the crown. Slide gate inside corrugated metal (CM) riser located on the waterside (WS) slope. Flap gate is located on the WS end. Concrete headwalls on both WS and landside (LS) ends. (no permit has been identified authorizing this structure, structure is owned by the City of Sacramento) [Additional Reference(s): DWR Levee Log, 2002. USACE Sacramento O&M Manual Unit 118, Part No. 2, October 1959, Drawing No. 1-4-392 Exhibit B, (Station 84+62)] FS Date: 12/20/2013

Inside view of concrete riser located on waterward shoulder--debris found at the bottom of riser.

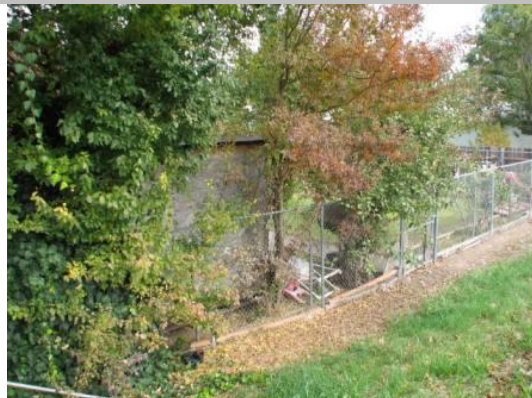
Photo 1 of 1 : FA_2018_NA0001_58_22_20180911_00019.jpg

LM Start	1.87	Rating **	U	Issue No.	22
LM End	1.87	Issue Type +	En	Location *	LS
Category	Earthen Levee			GPS Latitude/Longitude	
				Start	End
Item	Encroachments			38.628318 °	38.628318 °
				-121.436794 °	-121.436794 °
DWR ID	DWR_NA0001_07_s_2012_22				
Comment Code					
BU : Building					
Inspector Comment					
Wooden shed and landscaping along chain link fence within 10-ft of levee toe.

11/17/2011 Building is too close to the levee toe and obstructs visibility and access.

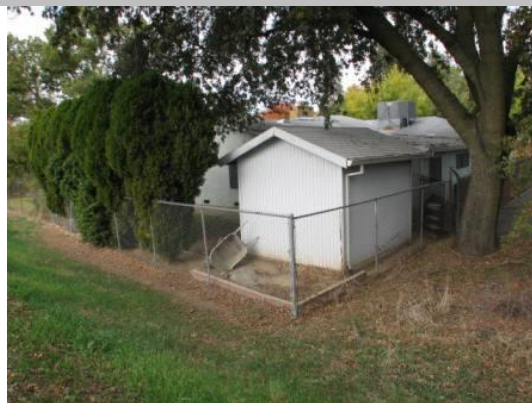
Photo 1 of 1 : FA_2018_NA0001_58_21_20180911_00018.jpg

LM Start	1.89	Rating **	U	Issue No.	21
LM End	1.89	Issue Type +	En	Location *	LS
Category	Earthen Levee			GPS Latitude/Longitude	
				Start	End
Item	Vegetation			38.628280 °	38.628280 °
				-121.436365 °	-121.436365 °
DWR ID	DWR_NA0001_07_s_2012_21				
Comment Code					
V6 : Landscaping					
Inspector Comment					
Wooden side building and juniper trees along chain link fence are within 10-ft of landside toe.

11/17/2011 Building and landscaping are too close to the levee toe.

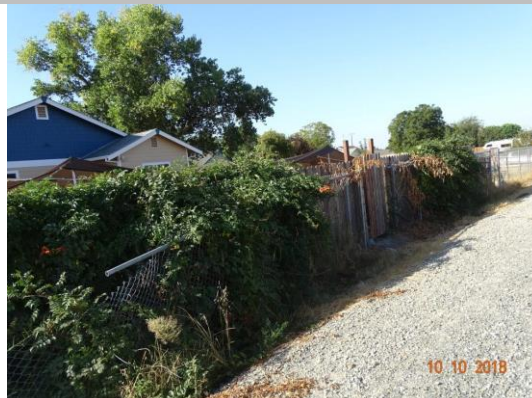
Photo 1 of 1 : FA_2018_NA0001_59_12_20181011_00016.jpg

LM Start	0.38	Rating **	U	Issue No.	12
LM End	0.38	Issue Type +	En	Location *	LS
Category	Earthen Levee			GPS Latitude/Longitude	
				Start	End
Item	Encroachments			38.668149°	38.668147°
				-121.440704°	-121.440533°
DWR ID	DWR_NA0001_08_f_2018_12				
Comment Code					
FE : Fence					
Inspector Comment					
Wooden fence with vegetation blocks visibility of levee easement.

View of wooden fence with vegetation that blocks visibility of levee easement. Fall 2018

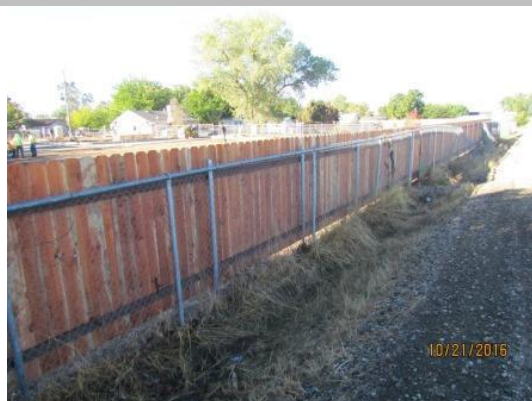
Photo 1 of 1 : FA_2018_NA0001_59_22_20180911_00009.jpg

LM Start	0.39	Rating **	U	Issue No.	22
LM End	0.40	Issue Type +	En	Location *	LS
Category	Earthen Levee			GPS Latitude/Longitude	
				Start	End
Item	Encroachments			38.668145 °	38.668118 °
				-121.440493 °	-121.440268 °
DWR ID	DWR_NA0001_08_s_2014_22				
Comment Code					
FE : Fence					
Inspector Comment					
Fence appears to be constructed at the property line. Fence limits visibility of the landside.

View of the fence at the landside levee toe. Fall 2016

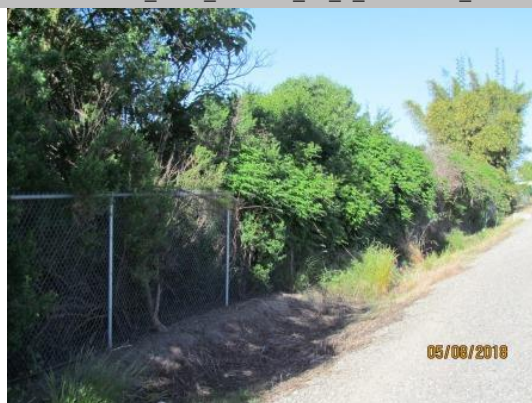
Photo 1 of 1 : FA_2018_NA0001_59_6_20180911_00004.jpg

LM Start	0.40	Rating **	U	Issue No.	6
LM End	0.43	Issue Type +	En	Location *	LS
Category	Earthen Levee			GPS Latitude/Longitude	
				Start	End
Item	Vegetation			38.668147°	38.668141°
				-121.440248°	-121.439755°
DWR ID	DWR_NA0001_08_s_2012_6				
Comment Code					
V6 : Landscaping					
Inspector Comment					
Vines on fence limit visibility.

View of the vines on fence obstructing visibility of landside toe.

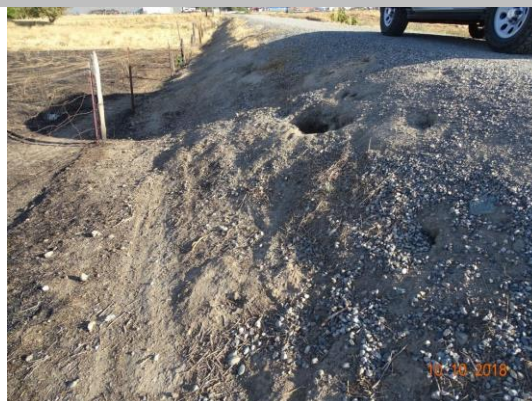
Photo 1 of 1 : FA_2018_NA0001_59_11_20181011_00015.jpg

LM Start	1.27	Rating **	M	Issue No.	11	
LM End	1.27	Issue Type +	Ma	Location *	LS	
Category	Earthen Levee			GPS Latitude/Longitude		
				Start		End
Item	Animal Control			38.661983 °		38.661983 °
				-121.431701 °		-121.431701 °
DWR ID	DWR_NA0001_08_f_2018_11					
Comment Code						
A2 : Repair the levee slope damaged by livestock and prevent large animal access.						
Inspector Comment						
Animal holes need to be backfilled.

View of animal holes on levee slope. Fall 2018

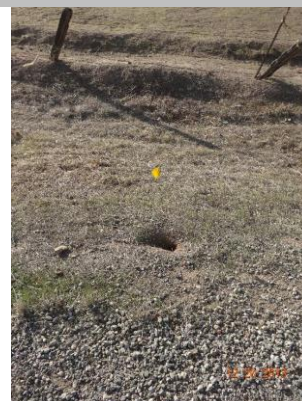
Photo 2 of 2 : UCIP_FA_2018_30689_56508.jpg

LM Start	1.28	Rating **	M	Issue No.	23 (cont)
LM End	1.28	Issue Type +	En	Location *	
Category	Supplemental			GPS Latitude/Longitude	
				Start	End
Item	DWR UCIP Field Study			38.661843 °	38.661843 °
				-121.431675 °	-121.431675 °
DWR ID	24815				
Comment Code					
Inspector Comment					
FS_ID:30689 DS_ID:24815 EP_NO: N/A Repair Type: Non-Urgent Crossing Status: Indicator Found UCIP Comments: unable to confirm if conduit or gas line cross levee or flag identifying problem areas. Need additional information. FIELD_STRUCT_DESC: Underground service alert (USA) markers found on waterside (WS) and landside (LS) during field inspection. FS Date: 12/20/2013

View of landward side.

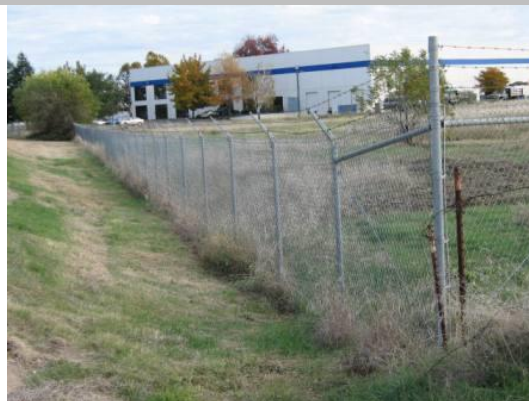
Photo 1 of 1 : FA_2018_NA0001_59_7_20180911_00005.jpg

LM Start	1.30	Rating **	M	Issue No.	7
LM End	1.33	Issue Type +	En	Location *	LS
Category	Earthen Levee			GPS Latitude/Longitude	
				Start	End
Item	Encroachments			38.661593 °	38.661370 °
				-121.431420 °	-121.430943 °
DWR ID	DWR_NA0001_08_s_2012_7				
Comment Code					
FE : Fence					
Inspector Comment					
Cyclone fence with barbed wire within 10' of toe for part of its alignment.

11/17/2011 Chainlink fence at levee toe.

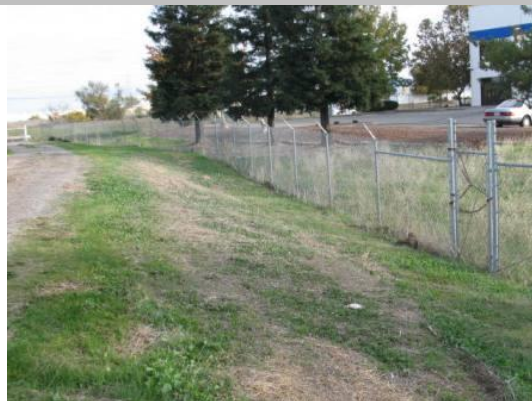
Photo 1 of 1 : FA_2018_NA0001_59_8_20180911_00006.jpg

LM Start	1.39	Rating **	M	Issue No.	8
LM End	1.43	Issue Type +	En	Location *	LS
Category	Earthen Levee			GPS Latitude/Longitude	
				Start	End
Item	Encroachments			38.660968 °	38.660828 °
				-121.430023 °	-121.429428 °
DWR ID	DWR_NA0001_08_s_2013_8				
Comment Code					
FE : Fence					
Inspector Comment					
Cyclone fence alignment returns to within 10' of toe.

11/17/2011 Chainlink fence alignment returns to the levee toe.

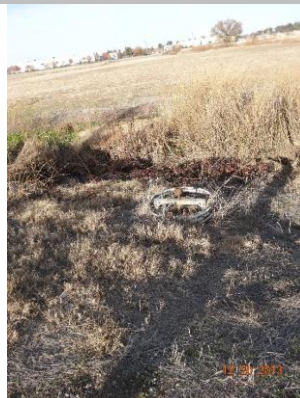
Photo 1 of 3 : UCIP_FA_2018_29329_54333.jpg

Comment Code						
Inspector Comment						
FS_ID:29329 DS_ID:24384 EP_NO: N/A Repair Type: Non-Urgent Crossing Status: Indicator Found UCIP Comments: Non-functional crossing--need to coordinate with owner, DWR-Inspector, and CVFPB to determine how to properly abandon crossing. FIELD_STRUCT_DESC: *ABANDONED* 24-inch corrugated metal (CM) pipe through the levee, 8 feet below the crown. Two CM cutoff walls around pipe. Slide gate in 30-inch CM riser and flap gate on waterside (WS) end. Concrete "U" headwall and splash apron on WS end. Landside (LS) end cutoff and plugged, riser filled with dirt. [Additional Reference(s): DWR Levee Log, 2002. USACE Sacramento O&M Manual Unit 118, Part No. 2, October 1959, Drawing No. 1-4-392 Exhibit B, (Station 72+10)] FS Date: 12/20/2013

View of riser with slide gate located on waterward side.

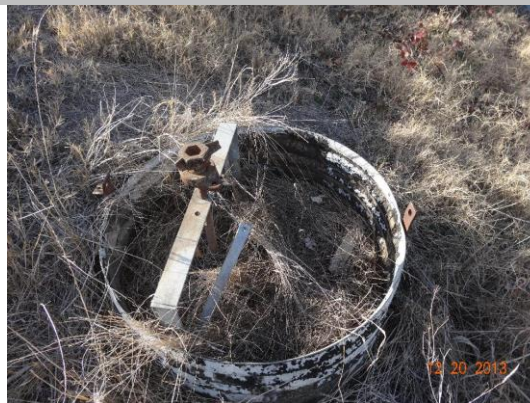
Photo 2 of 3 : UCIP_FA_2018_29329_54332.jpg

Slide gate non-functional--riser filled with soil.

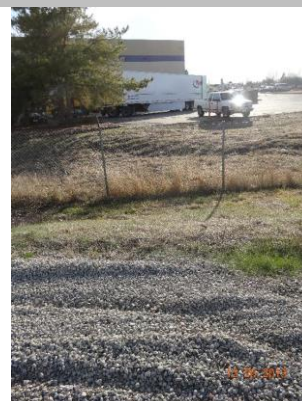
Photo 3 of 3 : UCIP_FA_2018_29329_54334.jpg

Comment Code						
Inspector Comment						
FS_ID:29329						
DS_ID:24384						
EP_NO: N/A						
Repair Type: Non-Urgent						
Crossing Status: Indicator Found						
UCIP Comments: Non-functional crossing--need to coordinate with owner, DWR-Inspector, and CVFPB to determine how to properly abandon crossing.						
FIELD_STRUCT_DESC: *ABANDONED* 24-inch corrugated metal (CM) pipe through the levee, 8 feet below the crown. Two CM cutoff walls around pipe. Slide gate in 30-inch CM riser and flap gate on waterside (WS) end. Concrete "U" headwall and splash apron on WS end. Landside (LS) end cutoff and plugged, riser filled with dirt.						
[Additional Reference(s): DWR Levee Log, 2002. USACE Sacramento O&M Manual Unit 118, Part No. 2, October 1959, Drawing No. 1-4-392 Exhibit B, (Station 72+10)]						
FS Date: 12/20/2013

View of landward side.

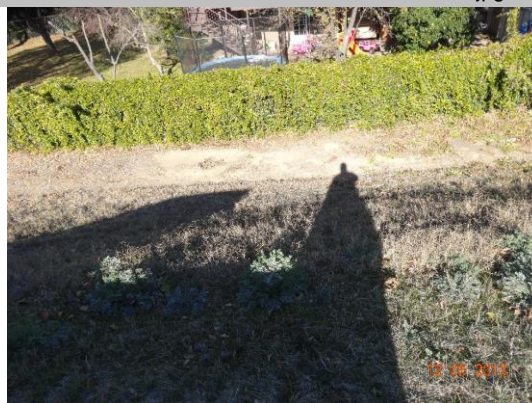
Photo 1 of 2 : UCIP_FA_2018_29347_54363.jpg

Comment Code						
Inspector Comment						
FS_ID:29347 DS_ID:24394 EP_NO: N/A Repair Type: Non-Urgent Crossing Status: Indicator Found UCIP Comments: 08/16/2017 DWR Deferred Maintenance Project (DMP), Vince Rodriguez, forwarded email received from Tim Kerr, General Manager of American River Flood Control District (ARFCD) with file "DWR Eligible Pipes Found in ARFCD" from ARFCD that shows the ownership and location of the pipes Tim Kerr investigated. No owner mentioned in email, ARFCD Staff Notes indicate riser in floodway near Beckenwood Way. (DWR UCIP - O. Magana) 12/05/2013 Need to contact owner to determine status of crossing. (DWR UCIP - O. Magana) FIELD_STRUCT_DESC: *Assumed ABANDONED* 12-inch steel pipe of unknown purpose through the levee, 14 feet below the crown. Riser unit on waterside (WS). (reference to 12-inch pipe scheduled to be abandoned (no clear direction of action taken available in permit recordation, see page 14 of 27 electronic permit copy) under Permit No. 4622, 1964 - County of Sacramento). [Additional Reference(s): DWR Levee Log, 2002. USACE Sacramento O&M Manual Unit 517, Part No. 1, November 1959, Drawing No. 1-4-0415, (Station 296+85)] FS Date: 12/5/2013

View of landward side.

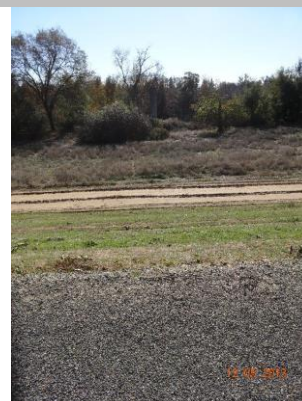
Photo 2 of 2 : UCIP_FA_2018_29347_54362.jpg

Comment Code						
Inspector Comment						
FS_ID:29347						
DS_ID:24394						
EP_NO: N/A						
Repair Type: Non-Urgent						
Crossing Status: Indicator Found						
UCIP Comments: 08/16/2017 DWR Deferred Maintenance Project (DMP), Vince Rodriguez, forwarded email received from Tim Kerr, General Manager of American River Flood Control District (ARFCD) with file "DWR Eligible Pipes Found in ARFCD" from ARFCD that shows the ownership and location of the pipes Tim Kerr investigated. No owner mentioned in email, ARFCD Staff Notes indicate riser in floodway near Beckenwood Way. (DWR UCIP - O. Magana)						
12/05/2013 Need to contact owner to determine status of crossing. (DWR UCIP - O. Magana)						
FIELD_STRUCT_DESC: *Assumed ABANDONED* 12-inch steel pipe of unknown purpose through the levee, 14 feet below the crown. Riser unit on waterside (WS). (reference to 12-inch pipe scheduled to be abandoned (no clear direction of action taken available in permit recordation, see page 14 of 27 electronic permit copy) under Permit No. 4622, 1964 - County of Sacramento). [Additional Reference(s): DWR Levee Log, 2002. USACE Sacramento O&M Manual Unit 517, Part No. 1, November 1959, Drawing No. 1-4-0415, (Station 296+85)]

View of waterward side--tall riser located approximately 200 feet away.

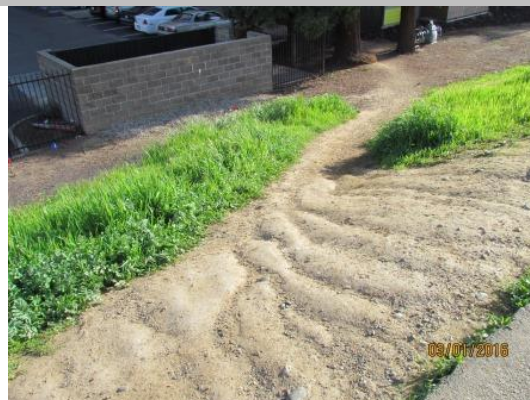
Photo 1 of 1 : FA_2018_NA0001_60_28_20180911_00010.jpg

LM Start	1.88	Rating **	M	Issue No.	28
LM End	1.88	Issue Type +	Ma	Location *	LS
Category	Earthen Levee			GPS Latitude/Longitude	
				Start	End
Item	Slope Stability			38.561171 °	38.561171 °
				-121.415808 °	-121.415808 °
DWR ID	DWR_NA0001_09_s_2016_28				
Comment Code					
S2 : Repair the levee slope damaged by foot traffic and prevent access where possible.					
Inspector Comment

View of the landside levee slope.

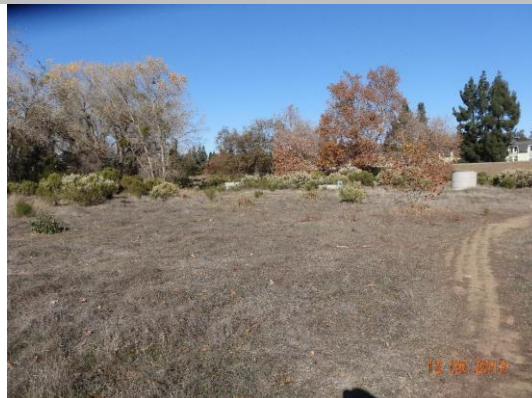
Photo 1 of 3 : UCIP_FA_2018_29351_54369.jpg

LM Start	1.93	Rating **	M	Issue No.	30	
LM End	1.93	Issue Type +	En	Location *		
Category	Supplemental			GPS Latitude/Longitude		
				Start	End	
Item	DWR UCIP Field Study			38.560889 °	38.560889 °	
				-121.417196 °	-121.417196 °	
DWR ID	24597					
Comment Code						
Inspector Comment						
FS_ID:29351						
DS_ID:24597						
EP_NO: 17587						
Repair Type: Non-Urgent						
Crossing Status: Indicator Found						
UCIP Comments: Unable to confirm if riser belongs to this crossing--need to coordinate with owner to determine specifics. Description needs to be updated.						
FIELD_STRUCT_DESC: 54-inch water main of unknown material through the levee at unknown depth. (54-inch pipe authorized under Permit No. 17587, 2003-City of Sacramento)						
FS Date: 12/5/2013

Three risers located on waterward berm.

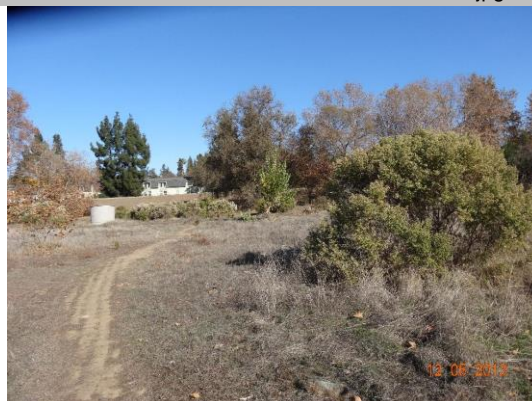
Photo 2 of 3 : UCIP_FA_2018_29351_54368.jpg

View of waterward berm looking toward levee crown from waterward berm edge.

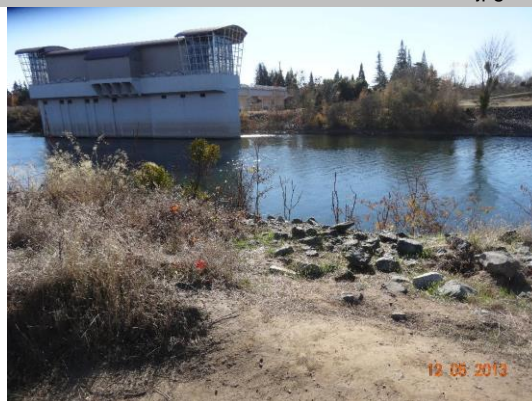
Photo 3 of 3 : UCIP_FA_2018_29351_54367.jpg

LM Start	1.93	Rating **	M	Issue No.	30 (cont)	
LM End	1.93	Issue Type +	En	Location *		
Category	Supplemental			GPS Latitude/Longitude		
				Start	End	
Item	DWR UCIP Field Study			38.560889 °	38.560889 °	
				-121.417196 °	-121.417196 °	
DWR ID	24597					
Comment Code						
Inspector Comment						
FS_ID:29351						
DS_ID:24597						
EP_NO: 17587						
Repair Type: Non-Urgent						
Crossing Status: Indicator Found						
UCIP Comments: Unable to confirm if riser belongs to this crossing--need to coordinate with owner to determine specifics. Description needs to be updated.						
FIELD_STRUCT_DESC: 54-inch water main of unknown material through the levee at unknown depth. (54-inch pipe authorized under Permit No. 17587, 2003-City of Sacramento)						
FS Date: 12/5/2013

View of waterward edge--rip rap armor along toe.

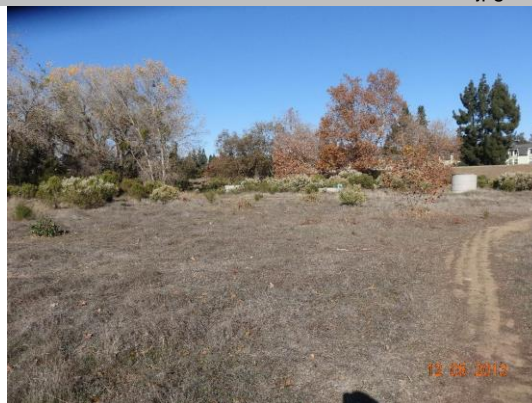
Photo 1 of 3 : UCIP_FA_2018_30124_55522.jpg

LM Start	1.95	Rating **	M	Issue No.	31
LM End	1.95	Issue Type +	En	Location *	
Category	Supplemental			GPS Latitude/Longitude	
				Start	End
Item	DWR UCIP Field Study			38.561064 °	38.561064 °
				-121.417323 °	-121.417323 °
DWR ID	24395				
Comment Code					
Inspector Comment					
FS_ID:30124					
DS_ID:24395					
EP_NO: N/A					
Repair Type: Non-Urgent					
Crossing Status: Indicator Found					
UCIP Comments: unable to confirm crossing--need to contact owner to determine status of crossing.					
FIELD_STRUCT_DESC: 60-inch sewer main through the American					
River overflow area. Erosion protection and rock revetment on					
waterside (WS) slope added under Permit No. 14487 (1986). [Additional					
Reference(s): DWR Levee Log, 2002]					
FS Date: 12/5/2013

View of berm on waterward side.

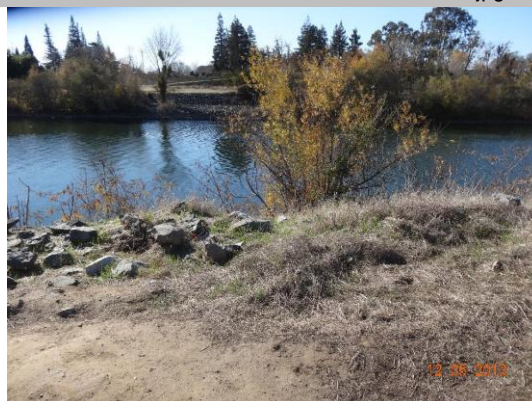
Photo 2 of 3 : UCIP_FA_2018_30124_55521.jpg

LM Start	1.95	Rating **	M	Issue No.	31 (cont)	
LM End	1.95	Issue Type +	En	Location *		
Category	Supplemental			GPS Latitude/Longitude		
				Start	End	
Item	DWR UCIP Field Study			38.561064 °	38.561064 °	
				-121.417323 °	-121.417323 °	
DWR ID	24395					
Comment Code						
Inspector Comment						
FS_ID:30124						
DS_ID:24395						
EP_NO: N/A						
Repair Type: Non-Urgent						
Crossing Status: Indicator Found						
UCIP Comments: unable to confirm crossing--need to contact owner to determine status of crossing.						
FIELD_STRUCT_DESC: 60-inch sewer main through the American River overflow area. Erosion protection and rock revetment on waterside (WS) slope added under Permit No. 14487 (1986). [Additional Reference(s): DWR Levee Log, 2002]						
FS Date: 12/5/2013

Rip rap used along waterward toe.

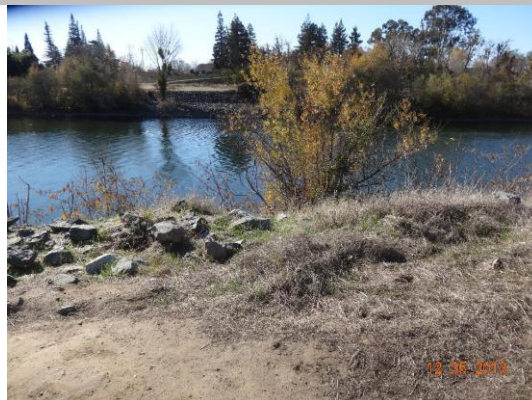
Photo 2 of 3 : UCIP_FA_2018_46085_54712.jpg

LM Start	1.96	Rating **	M	Issue No.	32
LM End	1.96	Issue Type +	En	Location *	
Category	Supplemental			GPS Latitude/Longitude	
				Start	End
Item	DWR UCIP Field Study			38.561119 °	38.561119 °
				-121.417581 °	-121.417581 °
DWR ID	24649				
Comment Code					
Inspector Comment					
FS_ID:46085 DS_ID:24649 EP_NO: 12188 Repair Type: Non-Urgent Crossing Status: Indicator Found UCIP Comments: unable to confirm crossing--need to contact owner to determine specifics and status of crossing. FIELD_STRUCT_DESC: 60-inch steel sewer main under the levee, approximately 21.6 feet below the crown. Two concrete cutoff walls around pipe under each shoulder. (60-inch pipe authorized under Permit No. 12188, 1979-Sacramento Regional County Sanitation District; erosion protection and rock revetment on waterside (WS) slope added under Permit No. 14487, 1986-). FS Date: 12/5/2013

View of waterward edge--rip rap used to armor toe.

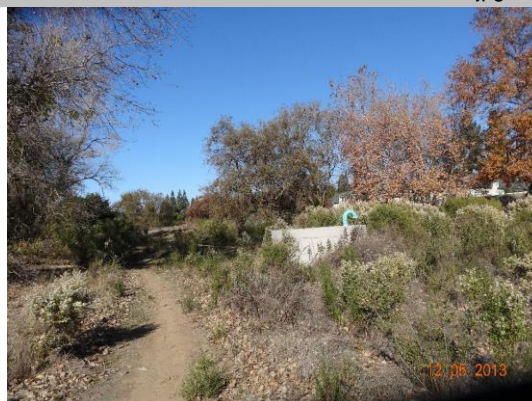
Photo 3 of 3 : UCIP_FA_2018_46085_54711.jpg

LM Start	1.96	Rating **	M	Issue No.	32 (cont)	
LM End	1.96	Issue Type +	En	Location *		
Category	Supplemental			GPS Latitude/Longitude		
				Start		End
Item	DWR UCIP Field Study			38.561119 °		38.561119 °
				-121.417581 °		-121.417581 °
DWR ID	24649					
Comment Code						
Inspector Comment						
FS_ID:46085 DS_ID:24649 EP_NO: 12188 Repair Type: Non-Urgent Crossing Status: Indicator Found UCIP Comments: unable to confirm crossing--need to contact owner to determine specifics and status of crossing. FIELD_STRUCT_DESC: 60-inch steel sewer main under the levee, approximately 21.6 feet below the crown. Two concrete cutoff walls around pipe under each shoulder. (60-inch pipe authorized under Permit No. 12188, 1979-Sacramento Regional County Sanitation District; erosion protection and rock revetment on waterside (WS) slope added under Permit No. 14487, 1986-). FS Date: 12/5/2013

View of second concrete cylinder located on waterward berm.

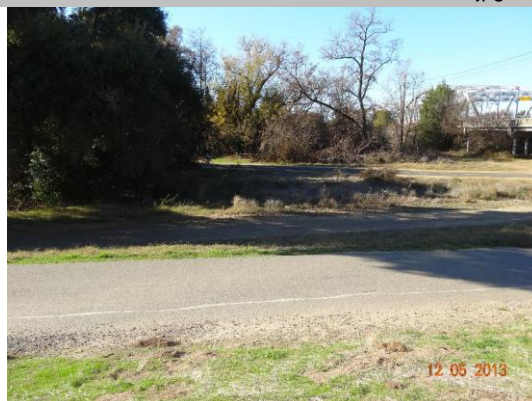
Photo 1 of 3 : UCIP_FA_2018_31309_57338.jpg

LM Start	2.51	Rating **	M	Issue No.	33
LM End	2.51	Issue Type +	En	Location *	
Category	Supplemental			GPS Latitude/Longitude	
				Start	End
Item	DWR UCIP Field Study			38.568767°	38.568767°
				-121.421178°	-121.421178°
DWR ID	24515				
Comment Code					
Inspector Comment					
FS_ID:31309 DS_ID:24515 EP_NO: N/A Repair Type: Non-Urgent Crossing Status: Indicator Found UCIP Comments: Unable to confirm crossing. will need to contact owner to determine specifics and status of crossing. FIELD_STRUCT_DESC: 36-inch corrugated metal (CM) drainage pipe through the levee at an unknown depth below the crown. Riser unit on waterside (WS). [Additional Reference(s): USACE Sacramento O&M Manual Unit 517, Part No. 1, November 1959, Drawing No. 1-4-0415, (Station 365+14)] FS Date: 12/5/2013

View of waterward side.

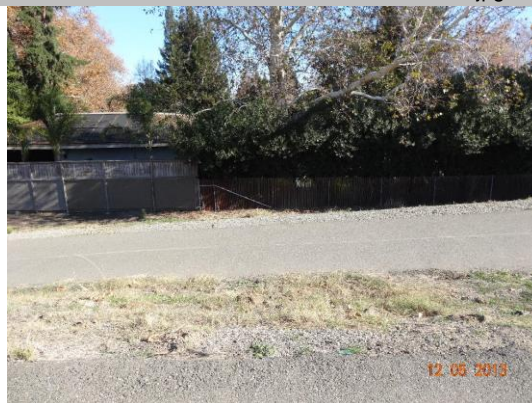
Photo 2 of 3 : UCIP_FA_2018_31309_57337.jpg

View of landward side.

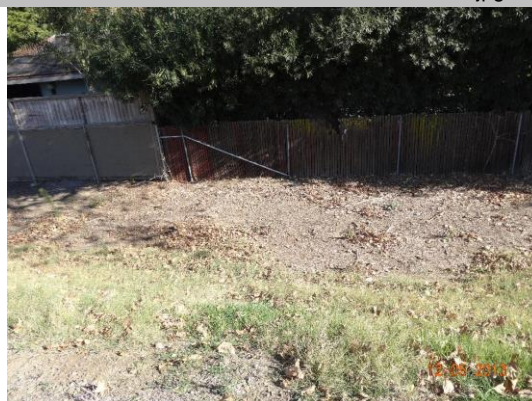
Photo 3 of 3 : UCIP_FA_2018_31309_57336.jpg

Landward side toe cleared.

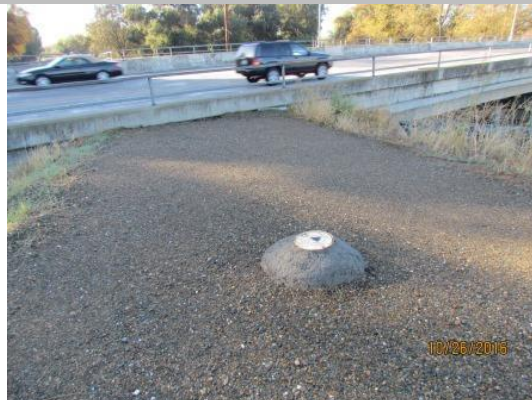
Photo 1 of 1 : FA_2018_NA0001_60_23_20180911_00006.jpg

LM Start	2.56	Rating **	U	Issue No.	23
LM End	2.56	Issue Type +	En	Location *	CR
Category	Earthen Levee			GPS Latitude/Longitude	
				Start	End
Item	Encroachments			38.569380 °	38.569380 °
				-121.421325 °	-121.421325 °
DWR ID	DWR_NA0001_09_f_2016_23				
Comment Code					
MW : Monitoring Well					
Inspector Comment					
Monitoring well does not meet Title 23 standards. Well should be flush with the levee crown.

View of the monitoring well on the levee crown.

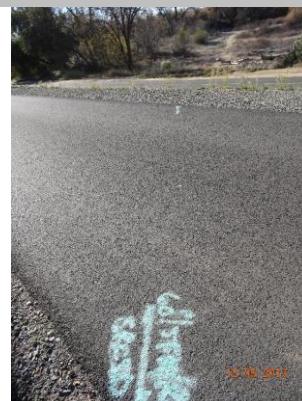
Photo 1 of 3 : UCIP_FA_2018_30125_55526.jpg

View of waterward side.

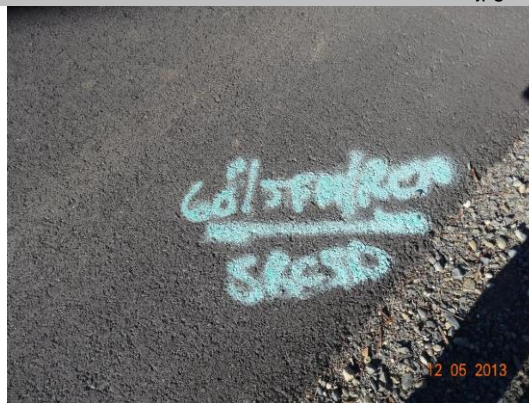
Photo 2 of 3 : UCIP_FA_2018_30125_55528.jpg

Underground service alert (USA) paint found on bike path on waterward side.

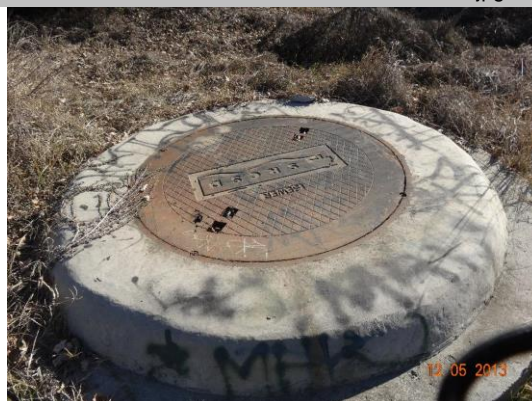
Photo 3 of 3 : UCIP_FA_2018_30125_55529.jpg

Manhole visible on waterward toe.

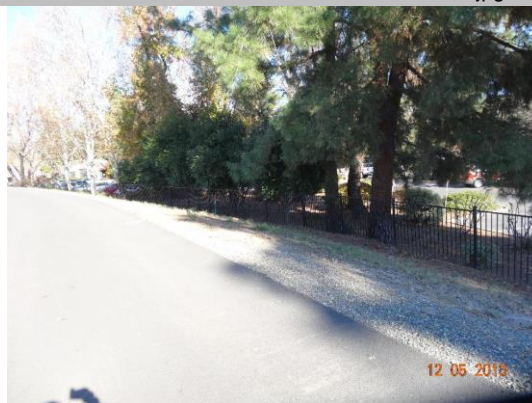
Photo 1 of 3 : UCIP_FA_2018_29633_54791.jpg

Comment Code						
Inspector Comment						
FS_ID:29633 DS_ID:24404 EP_NO: 12188 Repair Type: Non-Urgent Crossing Status: Indicator Found UCIP Comments: unable to confirm if crossing is still active--need to contact owner to determine status of crossing. FIELD_STRUCT_DESC: 60-inch concrete encased steel sewer line through the levee, 17.0 feet below the crown. Cutoff wall around pipe at the center of the levee. Rock revetment on waterside (WS) slope. Three pressure manholes in overflow area along pipe path. (60-inch force main sewerline authorized under Permit No. 12188, 1979-Sacramento Regional County Sanitation District) [Additional Reference(s): DWR Levee Log, 2002] FS Date: 12/5/2013

View of landward side.

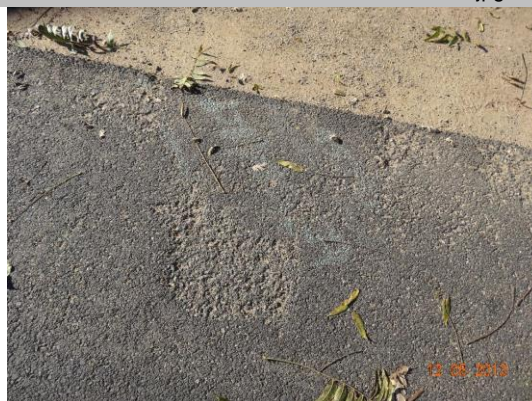
Photo 2 of 3 : UCIP_FA_2018_29633_54790.jpg

Underground service alert (USA) markings still present on levee crown.

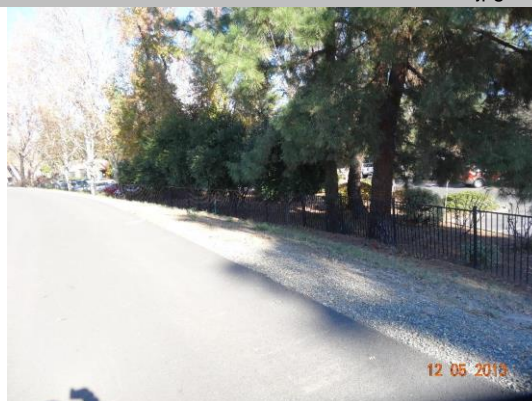
Photo 1 of 3 : UCIP_FA_2018_41437_55532.jpg

Overview of landward side.

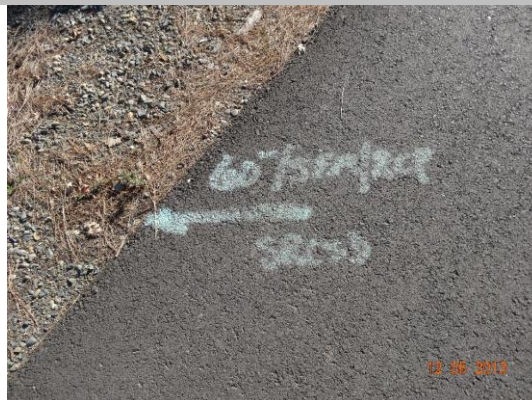
Photo 2 of 3 : UCIP_FA_2018_41437_55531.jpg

Underground service alert (USA) markings found on levee crown for 60-inch pipe.

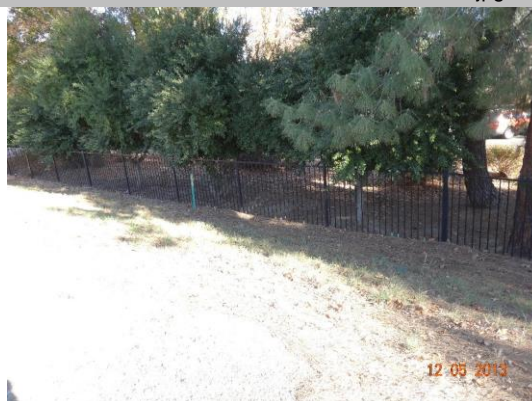
Photo 3 of 3 : UCIP_FA_2018_41437_55530.jpg

Marker visible on landward.

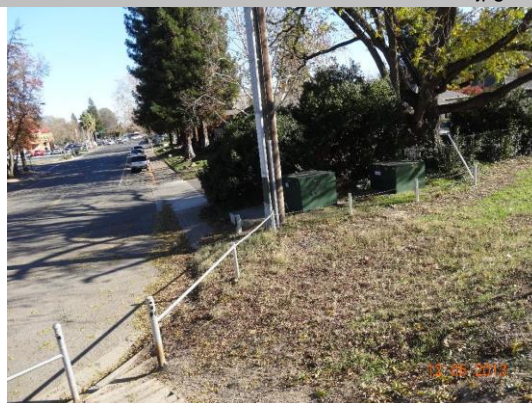
Photo 1 of 2 : UCIP_FA_2018_30684_56473.jpg

LM Start	3.42	Rating **	M	Issue No.	37
LM End	3.42	Issue Type +	En	Location *	
Category	Supplemental			GPS Latitude/Longitude	
				Start	End
Item	DWR UCIP Field Study			38.581572 °	38.581572 °
				-121.417819 °	-121.417819 °
DWR ID	24816				
Comment Code					
Inspector Comment					
FS_ID:30684 DS_ID:24816 EP_NO: N/A Repair Type: Non-Urgent Crossing Status: Indicator Found UCIP Comments: unable to determine if crossing goes through levee. Need to obtain additional information to confirm crossing. FIELD_STRUCT_DESC: Water fountain found on waterside (WS). FS Date: 12/5/2013

View of landward side.

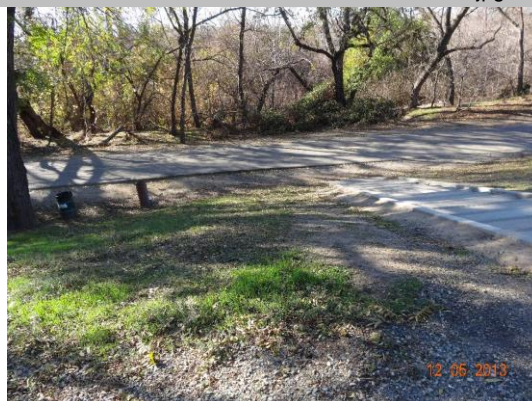
Photo 2 of 2 : UCIP_FA_2018_30684_56472.jpg

View of waterward side.

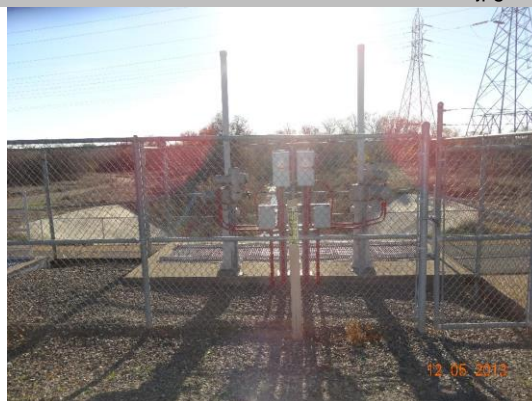
Photo 1 of 3 : UCIP_FA_2018_31304_57325.jpg

Concrete box and electrical box located on waterward shoulder.

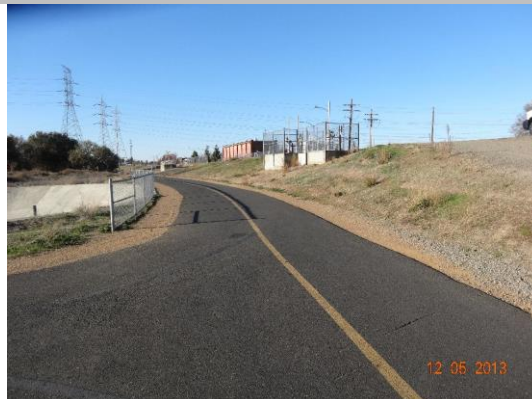
Photo 2 of 3 : UCIP_FA_2018_31304_57320.jpg

Bike path located on waterward side.

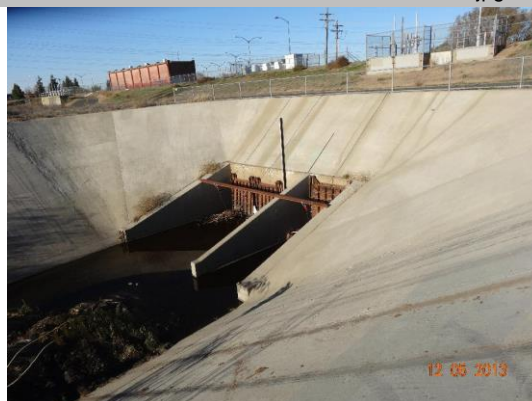
Photo 3 of 3 : UCIP_FA_2018_31304_57324.jpg

Concrete wall and wing walls located on waterward side.

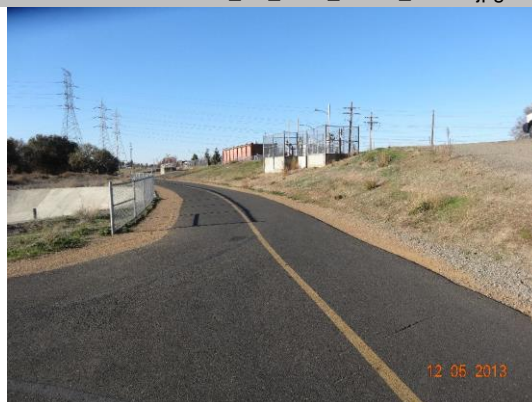
Photo 2 of 3 : UCIP_FA_2018_31306_57328.jpg

Bike path located on waterward side.

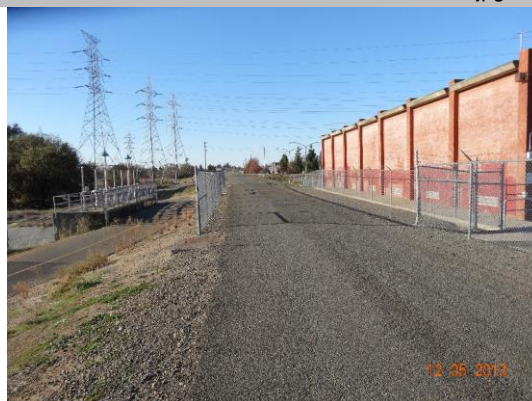
Photo 1 of 2 : UCIP_FA_2018_31307_57335.jpg

LM Start	3.72	Rating **	M	Issue No.	40	
LM End	3.72	Issue Type +	En	Location *		
Category	Supplemental			GPS Latitude/Longitude		
				Start	End	
Item	DWR UCIP Field Study			38.584710 °	38.584710 °	
				-121.421496 °	-121.421496 °	
DWR ID	24819					
Comment Code						
Inspector Comment						
FS_ID:31307						
DS_ID:24819						
EP_NO: N/A						
Repair Type: Non-Urgent						
Crossing Status: Found						
UCIP Comments: Unable to confirm is pipe crosses levee--no permit available.						
FIELD_STRUCT_DESC: Service box located on waterside (WS) and landside (LS). Unable to confirm crossing exists through levee. No permit found for this potential crossing.						
FS Date: 12/5/2013

View of concrete service box located on waterward shoulder.

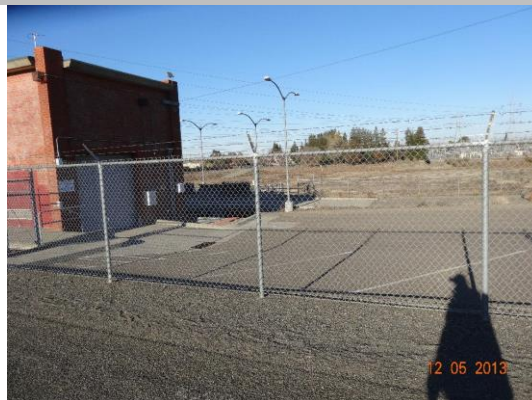
Photo 2 of 2 : UCIP_FA_2018_31307_57334.jpg

Concrete box located inside fenced area located on landward side.

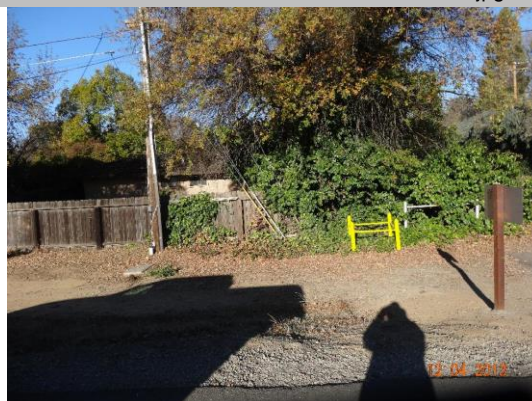
Photo 1 of 2 : UCIP_FA_2018_52670_57501.jpg

Comment Code						
Inspector Comment						
FS_ID:52670 DS_ID:24820 EP_NO: N/A Repair Type: Non-Urgent Crossing Status: Indicator Found UCIP Comments: 08/11/2017 PG&E records for this distribution main indicate that there were no leaks found on the 05/2015 leak survey and the pipeline is operating correctly according to the 12/2016 CP inspection. (DWR UCIP - A. McDonald)Unable to determine alignment of crossing, does it cross levee? Permit? FIELD_STRUCT_DESC: Protective posts located on landside (LS) for what appears to be for gas/petroleum line. Pipeline goes through levee and runs parallel. No permit found. In case of an emergency related to this pipeline, PG&E has identified the following contacts: PG&E's local pipeline engineer, Mike Aronoff at 916-307-9472 (cell), and Gas Control (north) at 800-442-4743. For non-emergency issues, please contact the local PG&E Gas Pipeline Operations and Maintenance (GPOM) supervisors for the Sacramento region, David Wade at 209-639-1039 (cell), or Ron Hicks at 916-396-9038 (cell). FS Date: 12/4/2013

View of protective posts located on landward side.

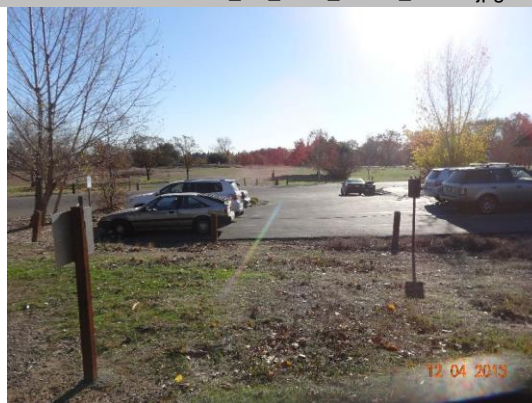
Photo 2 of 2 : UCIP_FA_2018_52670_57500.jpg

No signs of crossing on waterward side.

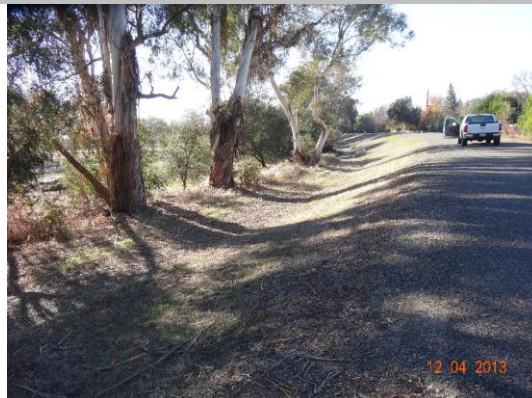
Photo 1 of 3 : UCIP_FA_2018_26281_47492.jpg

View of waterward slope.

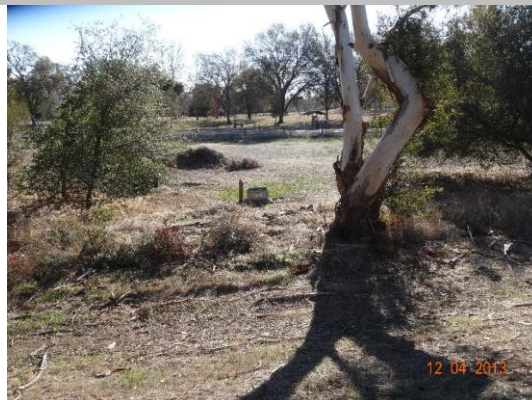
Photo 2 of 3 : UCIP_FA_2018_26281_47493.jpg

View of faucet located on waterward side.

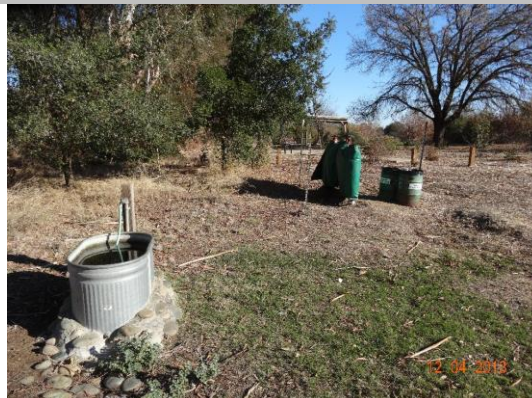
Photo 3 of 3 : UCIP_FA_2018_26281_47491.jpg

View of waterward side--faucet and water flow prevention system.

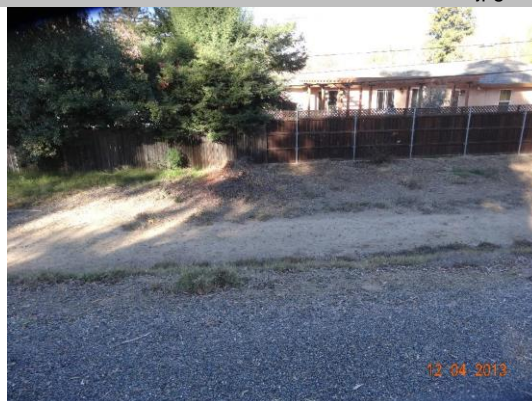
Photo 1 of 3 : UCIP_FA_2018_41550_47496.jpg

Comment Code					
Inspector Comment					
FS_ID:41550 DS_ID:24413 EP_NO: 2806 Repair Type: Non-Urgent Crossing Status: Found UCIP Comments: 08/16/2017 DWR Deferred Maintenance Project (DMP), Vince Rodriguez, forwarded email received from Tim Kerr, General Manager of American River Flood Control District (ARFCD) with file "DWR Eligible Pipes Found in ARFCD" from ARFCD that shows the ownership and location of the pipes Tim Kerr investigated. Owner of this crossing is identified as the County of Sacramento, ARFCD Staff Notes indicate Near McClaren Dr. (DWR UCIP - O. Magana) 12/04/2013 Need to determine status of crossing--Need to coordinate with utility owner. (DWR UCIP - O. Magana) FIELD_STRUCT_DESC: 30-inch corrugated metal (CM) pipe through the levee, 15 feet below the crown. Cutoff wall around pipe under landside (LS) shoulder. Flap gate and slide gate in concrete pipe well on the waterside (WS) shoulder. Large drain canal cut across the WS berm. (30-inch pipe authorized under Permit No. 2806, 1958 - County of Sacramento) [Additional Reference(s): DWR Levee Log, 2002] FS Date: 12/4/2013

View of landward side.

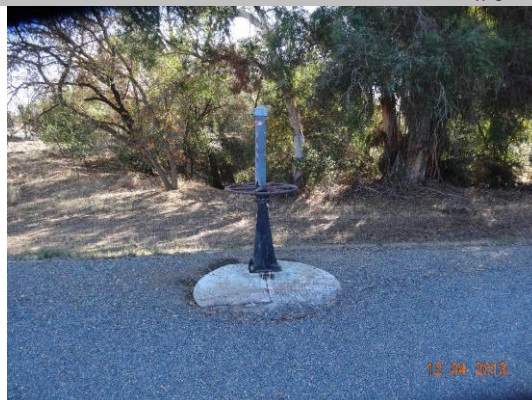
Photo 2 of 3 : UCIP_FA_2018_41550_47495.jpg

View of gate stem located on waterward shoulder.

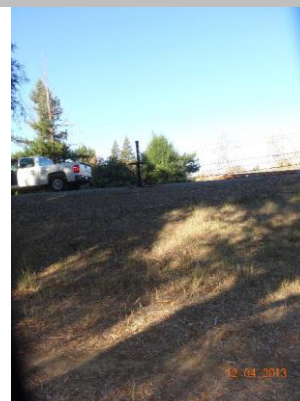
Photo 3 of 3 : UCIP_FA_2018_41550_47499.jpg

Comment Code						
Inspector Comment						
FS_ID:41550 DS_ID:24413 EP_NO: 2806 Repair Type: Non-Urgent Crossing Status: Found UCIP Comments: 08/16/2017 DWR Deferred Maintenance Project (DMP), Vince Rodriguez, forwarded email received from Tim Kerr, General Manager of American River Flood Control District (ARFCD) with file "DWR Eligible Pipes Found in ARFCD" from ARFCD that shows the ownership and location of the pipes Tim Kerr investigated. Owner of this crossing is identified as the County of Sacramento, ARFCD Staff Notes indicate Near McClaren Dr. (DWR UCIP - O. Magana) 12/04/2013 Need to determine status of crossing--Need to coordinate with utility owner. (DWR UCIP - O. Magana) FIELD_STRUCT_DESC: 30-inch corrugated metal (CM) pipe through the levee, 15 feet below the crown. Cutoff wall around pipe under landside (LS) shoulder. Flap gate and slide gate in concrete pipe well on the waterside (WS) shoulder. Large drain canal cut across the WS berm. (30-inch pipe authorized under Permit No. 2806, 1958 - County of Sacramento) [Additional Reference(s): DWR Levee Log, 2002] FS Date: 12/4/2013

View of waterward slope.

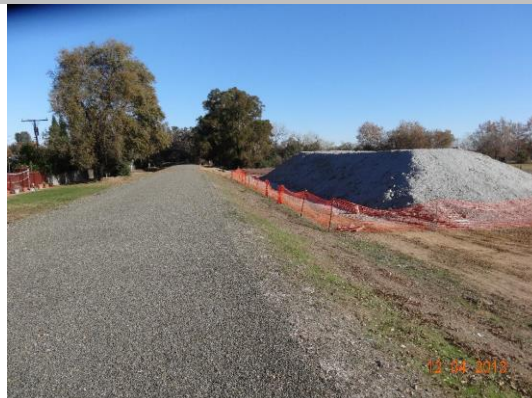
Photo 1 of 3 : UCIP_FA_2018_31284_57285.jpg

LM Start	1.04	Rating **	M	Issue No.	34
LM End	1.04	Issue Type +	En	Location *	
Category	Supplemental			GPS Latitude/Longitude	
				Start	End
Item	DWR UCIP Field Study			38.586813 °	38.586813 °
				-121.337643 °	-121.337643 °
DWR ID	24821				
Comment Code					
Inspector Comment					
FS_ID:31284 DS_ID:24821 EP_NO: N/A Repair Type: Non-Urgent Crossing Status: Found UCIP Comments: Unable to determine reason for box and whether there is a utility that crosses levee. No permit found. FIELD_STRUCT_DESC: Service box located on waterside (WS). No permit found. FS Date: 12/4/2013

Overview of levee crown at crossing.

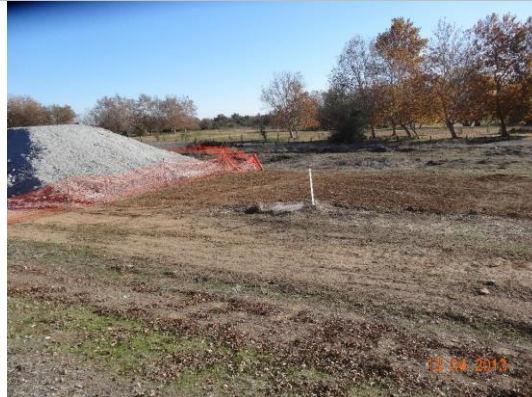
Photo 2 of 3 : UCIP_FA_2018_31284_57286.jpg

Concrete vault located on waterward side.

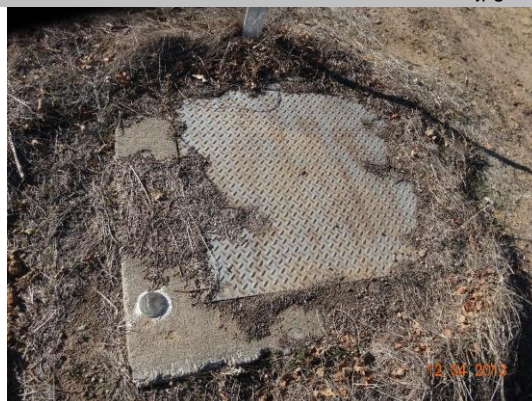
Photo 3 of 3 : UCIP_FA_2018_31284_57288.jpg

LM Start	1.04	Rating **	M	Issue No.	34 (cont)	
LM End	1.04	Issue Type +	En	Location *		
Category	Supplemental			GPS Latitude/Longitude		
				Start	End	
Item	DWR UCIP Field Study			38.586813 °	38.586813 °	
				-121.337643 °	-121.337643 °	
DWR ID	24821					
Comment Code						
Inspector Comment						
FS_ID:31284 DS_ID:24821 EP_NO: N/A Repair Type: Non-Urgent Crossing Status: Found UCIP Comments: Unable to determine reason for box and whether there is a utility that crosses levee. No permit found. FIELD_STRUCT_DESC: Service box located on waterside (WS). No permit found. FS Date: 12/4/2013

Close up of concrete box located on waterward side.

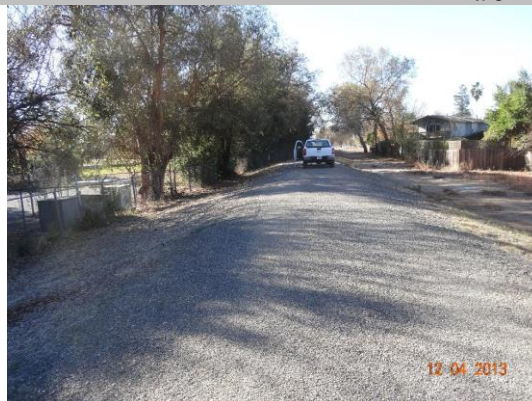
Photo 1 of 3 : UCIP_FA_2018_41536_47550.jpg

LM Start	1.28	Rating **	M	Issue No.	35	
LM End	1.28	Issue Type +	En	Location *		
Category	Supplemental			GPS Latitude/Longitude		
				Start		End
Item	DWR UCIP Field Study			38.583873 °		38.583873 °
				-121.340037 °		-121.340037 °
DWR ID	24097					
Comment Code						
Inspector Comment						
FS_ID:41536						
DS_ID:24097						
EP_NO: 12276						
Repair Type: Non-Urgent						
Crossing Status: Indicator Found						
UCIP Comments: Unable to find markers indicating crossing through levee.						
FIELD_STRUCT_DESC: Two 3-inch polyvinyl chloride (PVC) electrical conduits through the levee, 3 feet below the crown. Northeast Sewage Treatment Plant on waterside (WS). Conduits extend from treatment plant to transformers located on WS. (two 3-inch conduits authorized under Permit No. 12276-1980) [Additional Reference(s): DWR Levee Log, 2002]						
FS Date: 12/4/2013

Overview of levee looking downstream.

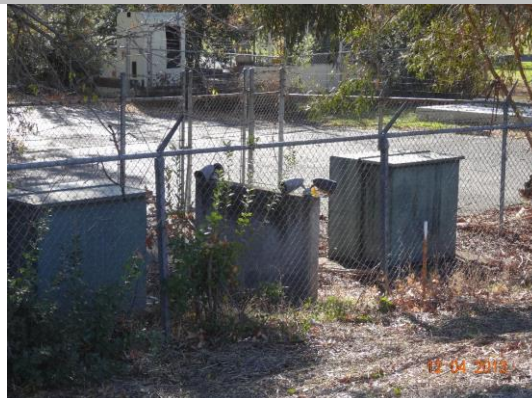
Photo 2 of 3 : UCIP_FA_2018_41536_47549.jpg

View of transformers located on waterward side.

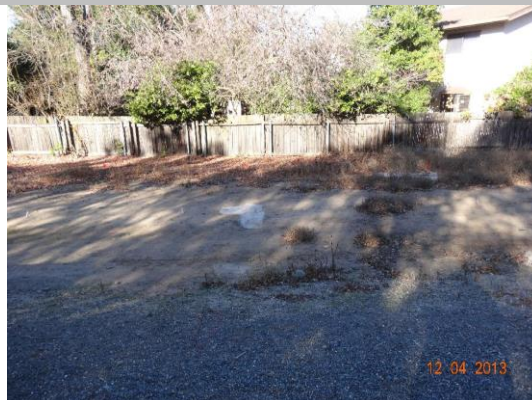
Photo 3 of 3 : UCIP_FA_2018_41536_47551.jpg

View of landward side.

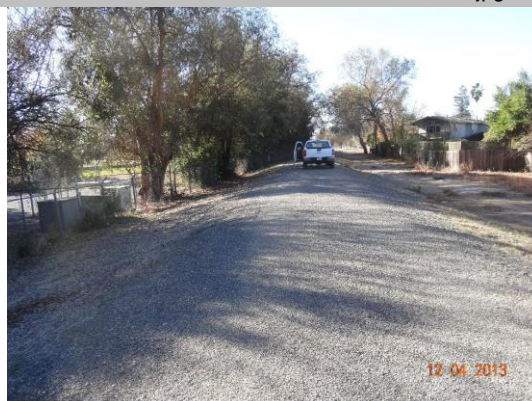
Photo 1 of 3 : UCIP_FA_2018_26299_47575.jpg

LM Start	1.28	Rating **	M	Issue No.	36
LM End	1.28	Issue Type +	En	Location *	
Category	Supplemental			GPS Latitude/Longitude	
				Start	End
Item	DWR UCIP Field Study			38.583873 °	38.583873 °
				-121.340037 °	-121.340037 °
DWR ID	24477				
Comment Code					
Inspector Comment					
FS_ID:26299 DS_ID:24477 EP_NO: 7993 Repair Type: Non-Urgent Crossing Status: Found UCIP Comments: 12/04/2013 Unable to confirm if crossing buried is the same as this crossing. (DWR UCIP - O. Magana) FIELD_STRUCT_DESC: 6-inch plastic lined steel pipe through the levee at unknown depth. Steel cutoff wall around pipe at center of levee. (6-inch line authorized under Permit No. 7993, 7993-A, 1973 - Northeast Sacramento County c/o Sanitation District Department of Public Works Water Quality Division) FS Date: 12/4/2013

Overview of levee crown looking downstream.

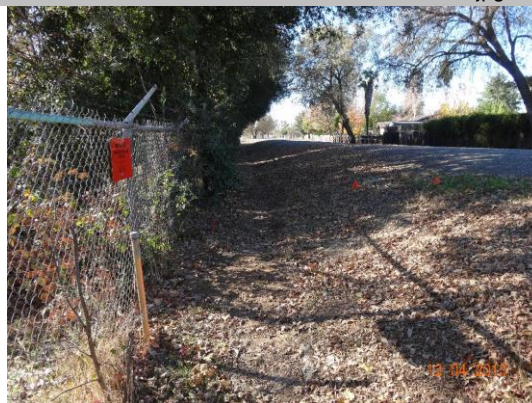
Photo 2 of 3 : UCIP_FA_2018_26299_47574.jpg

View of waterward side--Underground Alert System markers showing alignment.

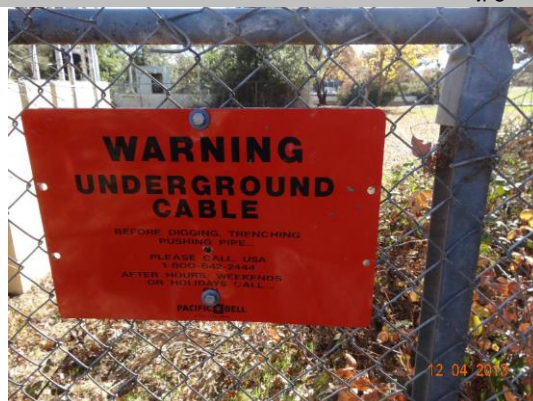
Photo 3 of 3 : UCIP_FA_2018_26299_47573.jpg

LM Start	1.28	Rating **	M	Issue No.	36 (cont)	
LM End	1.28	Issue Type +	En	Location *		
Category	Supplemental			GPS Latitude/Longitude		
				Start	End	
Item	DWR UCIP Field Study			38.583873 °	38.583873 °	
				-121.340037 °	-121.340037 °	
DWR ID	24477					
Comment Code						
Inspector Comment						
FS_ID:26299 DS_ID:24477 EP_NO: 7993 Repair Type: Non-Urgent Crossing Status: Found UCIP Comments: 12/04/2013 Unable to confirm if crossing buried is the same as this crossing. (DWR UCIP - O. Magana) FIELD_STRUCT_DESC: 6-inch plastic lined steel pipe through the levee at unknown depth. Steel cutoff wall around pipe at center of levee. (6-inch line authorized under Permit No. 7993, 7993-A, 1973 - Northeast Sacramento County c/o Sanitation District Department of Public Works Water Quality Division) FS Date: 12/4/2013

Sign for unground cable with contact information.

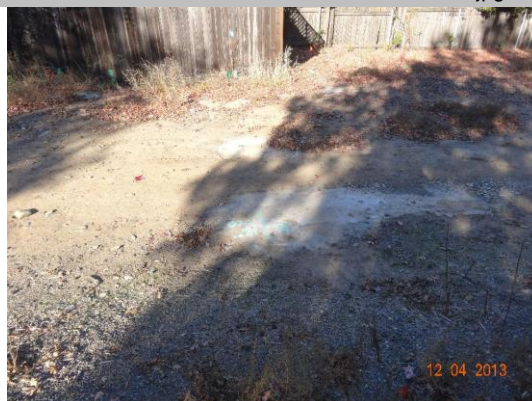
Photo 3 of 3 : UCIP_FA_2018_26296_47560.jpg

Comment Code						
Inspector Comment						
FS_ID:26296 DS_ID:24568 EP_NO: 3599B Repair Type: Non-Urgent Crossing Status: Indicator Found UCIP Comments: Need to determine status of structure-unable to determine if crossing is being used. Only indicator visible during inspection was the underground alert service markers and spray paint visible on the levee crown. FIELD_STRUCT_DESC: [River Walkway Station] 1 of 3: 12-inch concrete encased pipe through the levee, 15.3 feet below the crown. Two cutoff walls around pipe in line with each shoulder. Slide gate in concrete gate structure at landside (LS) toe-not found 2013. Sewage treatment plant on waterside (WS). Control valve in concrete box on the WS. Contact: Sacramento Regional Office 875-9400; Oscar Starks (Supervisor) 916-204-5143; Troy Shurock 916-599-2413. (one 54-inch and two 42-inch pipes authorized under Permit No. 3599B, 1964-County of Sacramento, Department of Public Works Northeast Sacramento County Sanitation District) [Additional Reference(s): DWR Levee Log, 2002] FS Date: 12/4/2013

View of landward side.

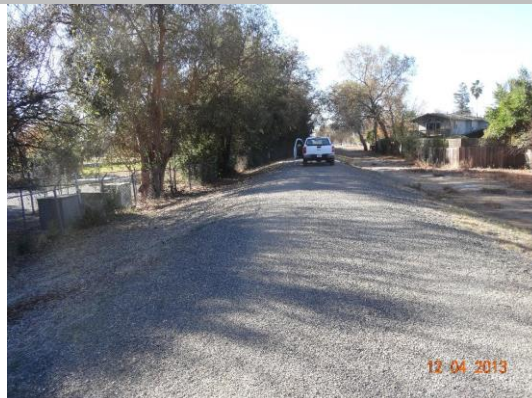
Photo 1 of 3 : UCIP_FA_2018_26298_47569.jpg

Comment Code						
Inspector Comment						
FS_ID:26298 DS_ID:24567 EP_NO: 3599A Repair Type: Non-Urgent Crossing Status: Found UCIP Comments: Need to determine status of structure. Need to coordinate with owner to determine maintenance records to confirm integrity. FIELD_STRUCT_DESC: [River Walkway Station] 2 of 3: 36-inch concrete encased pipe through the levee, 6.9 feet below the crown. Two cutoff walls around pipe in line with each shoulder. Slide gate in concrete gate structure at landside (LS) toe. Sewage treatment plant on waterside (WS). Control valve in concrete box on the WS. Contact: Sacramento Regional Office 875-9400; Oscar Starks (Supervisor) 916-204-5143; Troy Shurock 916-599-2413. (one 54-inch and two 42-inch pipes authorized under Permit No. 3599B, 1964-County of Sacramento, Department of Public Works Northeast Sacramento County Sanitation District) [Additional Reference(s): DWR Levee Log, 2002] FS Date: 12/4/2013

Overview of levee crown.

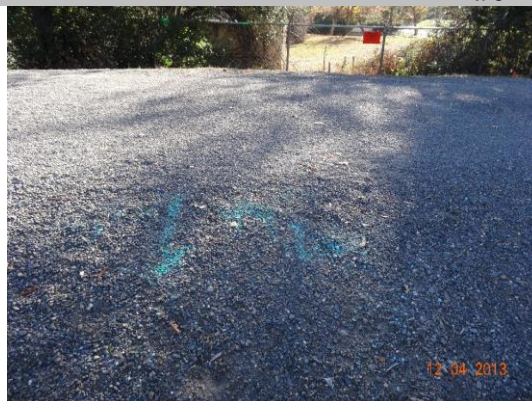
Photo 2 of 3 : UCIP_FA_2018_26298_47571.jpg

USA markers indicate alignment through levee crown.
